Case Study – Kinder ‘Essential Seal’ Dust Containment Solution

Kinder Australia Product:	<u>K-Sure® Belt Support, K-Snap-Loc® Dust Seal, K-Containment® Seal</u>
Product Category:	Conveyor Skirting & Transfer
Location:	Mount Magnet, Western Australia
Conveyed Materials:	Gold
Conveyor Belt Width:	750mm
Production Capacity:	Approx. 1.5 m/s, 90 – 120 tonnes per hour
Installation Date:	September 2018

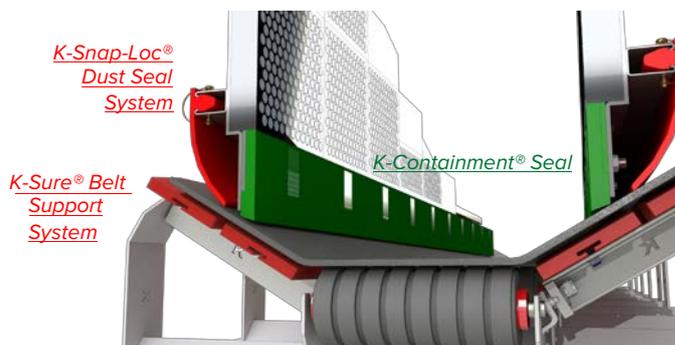
ABOVE
Kinder ‘Essential Seal’ Dust Containment Solution

The solution consists of **K-Sure® Belt Support System**, 2m long light duty retro-fitted impact bed, wing rollers were replaced with UHMWPE support rails, providing a supported belt, effective skirting seal and dust suppression. The other benefits of K-Sure® Belt Support Systems include roller failure reductions in transfer points, due to less moving components and the elimination of conveyor belt edge sag, leading to improved conveyor skirting profile and efficiency.

K-Snap-Loc® Dust Seal System, a high performance engineered, flexible polyurethane material was installed. This provided effective conformance to the conveyor belt profile, the self-adjusting benefits meant less maintenance time and resources than conventional skirting.

Lastly **K-Containment® Seal**, an internal hard skirt to contain the larger asset was installed due to the flexibility of the polyurethane, the higher durometer allows the polyurethane to handle larger material.

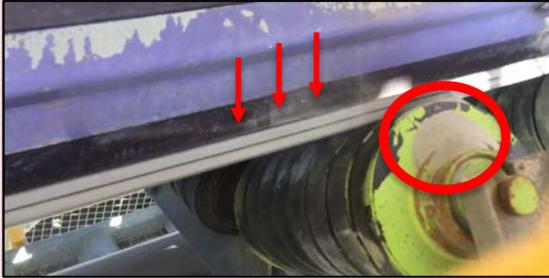
BEFORE

Standard rubber skirting and impact idlers were used as the main line of defence against dust and spillage accumulating around the base of the structure and transfer point. To alleviate material spillage, frequent hosing was necessary. Dust emissions were also contributing to roller bearing contamination, causing roller seizure that led to frequent and necessary roller replacements.

Dust emission from transfer point (seized roller)

Kinder’s ‘Essential Seal’, a highly effective conveyor belt support and conveyor skirting dust containment solution was proposed, accepted and installed by the customer in September 2018. Kinder ‘Essential Seal’ solution provides effective suppression of dust emissions around high impact transfer points.

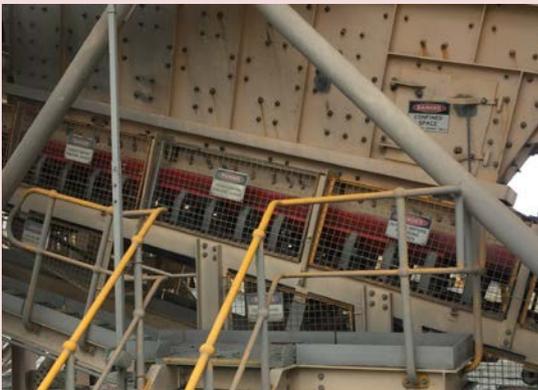
AFTER

Kinder ‘Essential Seal’ Dust Containment Installation

In February 2020, extremely positive feedback from the customer was received, **K-Sure® Belt Support System** has to date shown no visible signs of wear. Similarly, **K-Snap-Loc® Dust Seal System** and **K-Containment® Seal** are still both in top condition. The installation of Kinder ‘Essential Seal’ dust containment solution has been successful in minimising the dust and spillage issues at transfer points.
