CASE STUDY: K-Containment Seal

Kinder Australia Products:	<u>K-Containment Seal</u>
Product Category:	Conveyor Belt Skirting and Sealing
Product:	Concrete
Customer:	New Zealand Concrete Supplier – quarry products
Production Rate:	300 tonnes per hour
Belt Speed:	1 metre per second

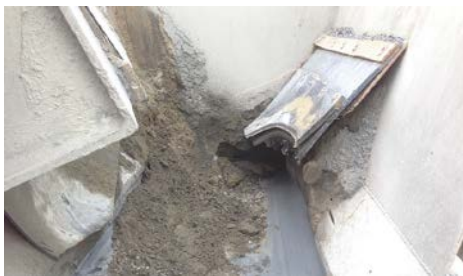
Our customer operates with a conveyor transfer point fed by a second conveyor that has a feed angle of 90 degrees. The weight pressure of the falling material was pushing the conveyor belt itself off-centre, becoming **misaligned and causing material spillage**.

At a production rate of 300 tonnes per hour, the fugitive material quickly accumulated, causing the trough rollers to seize up as well as creating a trip/slip hazard to workers. The associated conveyor skirting and steel holding plate in close proximity was subsequently showing signs of premature wear. Located in a difficult area, the 12mm traditional rubber skirting could not be changed without considerable effort.

Above: **BEFORE** pic showing 90 degree feed conveyor angle.

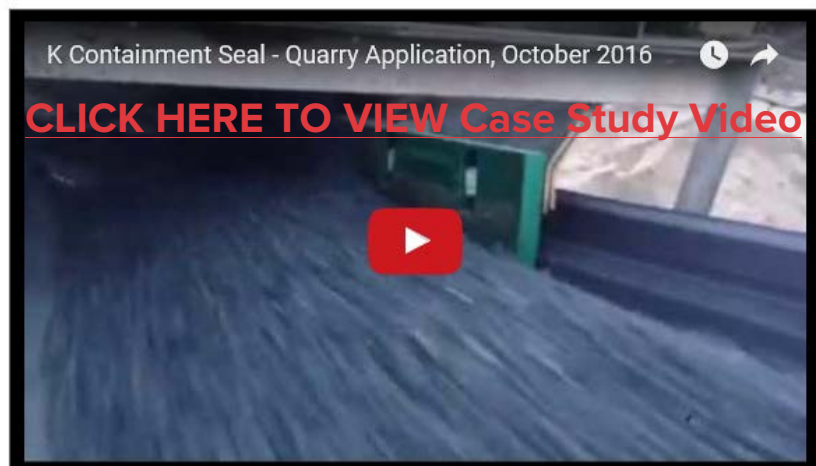
Right: **AFTER** pic showing contained material

K-Containment Seal was installed inside the chute wall and the spillage problem at the feed conveyor from trucks to the storage aggregate bins has been resolved - our customer is delighted.

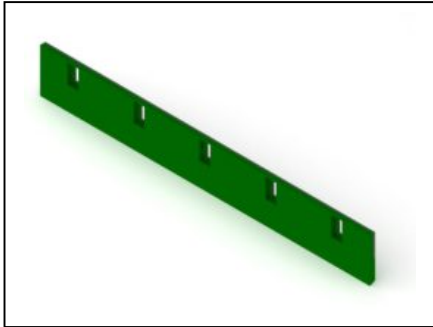
K-Containment Seal is lightweight to manoeuvre and simple to install with a slotted arrangement that presents on the outer of the chute wall. When wear eventually occurs, it can be adjusted and lowered to extend its wear life even further.

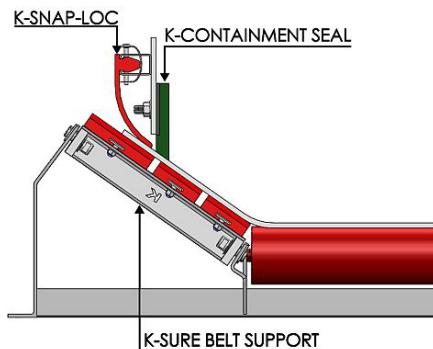
Pictured above is the ideal arrangement of K-Containment Seal, with K-Snap-Loc® Skirting and K-Sure® Belt Support. This combination creates the essential seal, optimising performance potential of each component.
