CASE STUDY: K-Containment Seal

Kinder Australia Product:	<u>K-Containment Seal</u>
Product Category:	Conveyor Skirting and Sealing
Location:	Auckland, New Zealand
Conveyed Materials:	Aggregate for Concrete Manufacture
Conveyed Belt Width/Speed:	900mm / 1 metre per sec
Rate / tonnes per hour	200
Installation Date:	April 2017

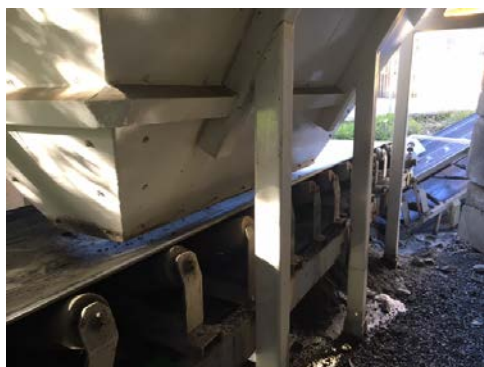
The concrete batching plant utilised standard trough bases and steel rollers. With no effective skirting & sealing system in place, the site identified two major challenges to overcome. Excessive material spillage was a primary issue in and around the conveyor as well as the conveyor being fed onto. This resulted in production slowdowns, with maintenance time, resources and additional costs directed towards cleaning up the excessive material spillage.

Material build up on the conveyor system was also identified, causing inefficient belt tracking, which in turn impacted on the operations continuous productivity aspirations.

RIGHT
Image
BEFORE Installation

A thorough evaluation of the sites inefficiencies was conducted and assessed. Due to its unsurpassed resistance to wear qualities Kinder Australia's **K-Containment Seal** skirting solution was recommended and implemented.

The skirting and sealing overhaul also involved new frames to be installed in conjunction with packers to ensure 100% linear loading zone. Brackets were manufactured and welded to the existing bin structure, ensuring rigidity and superior product performance. Installation preparation and process was simple and production downtime was minimal to facilitate the changeover, with the whole installation process meeting the client's satisfaction.

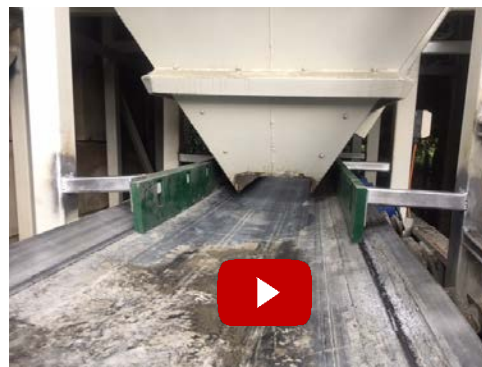
LEFT
Image
AFTER Installation

Satisfactory reports from the concrete batching plant highlight **K-Containment Seal's** exceptional product performance and its effectiveness in controlling material spillage, with maintenance crew commenting "*virtually no material spillage evident around the skirting area*". Cleaning up and dumping excessive material spillage costs have now been eliminated and plant production levels have returned to normal.
