Case Study – K-Flexal® Elastic Belt Support System

Kinder Australia Product:	<u>K-Flexal® Elastic Belt Support System</u>
Product Category:	Conveyor Skirting & Transfer
Location:	International
Conveyed Materials:	Coal & Iron Ore
Conveyor Belt Width:	1800BW
Production Capacity:	3m / sec, 1200 tonnes / hr, material size 0 < 100mm, fall height 3m
Installation Date:	2017

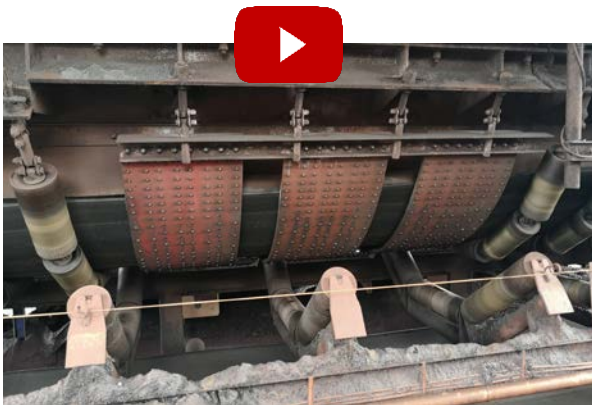
ABOVE
Successful K-Flexal® installation Photo.

K-Flexal® Elastic Belt Support System was installed and has effectively solved these problems by providing elasticity to absorb shock and the full force of the impacts. A team of Engineers also designed special hanging supports to support the polyurethane elastic straps.

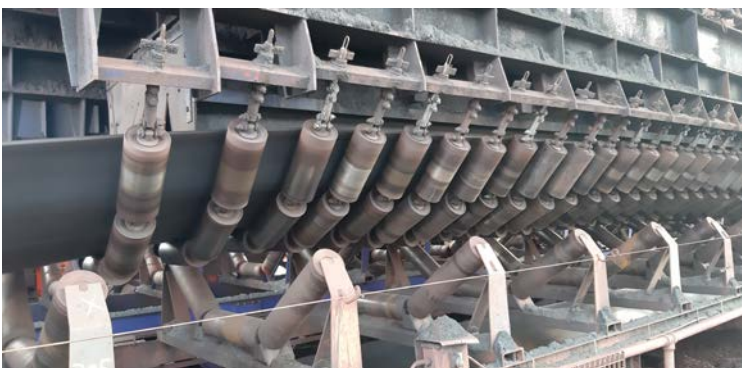
BEFORE

Operating at 1200 tonnes per hour, the abrasive properties of Coal and Iron Ore and a fall height of 3 meters was observed to be delivering high impact shocks, this was the leading contributor to belt damage and gradual roller failures.

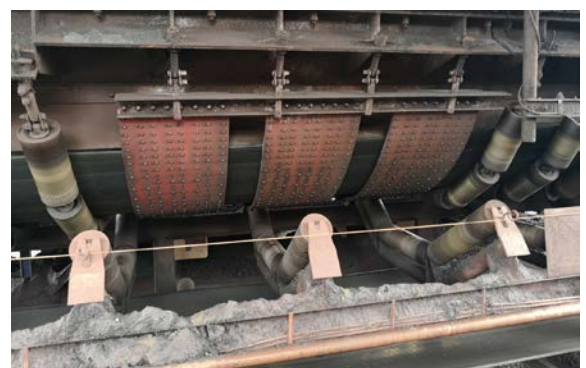
AFTER

Client feedback points to successful installation, K-Flexal® Elastic Belt Support System continues to be highly effective in providing complete belt support at critical points. K-Flexal® cross belt polyurethane elastic straps absorb the brunt of the impact, protecting the belt and leaving it intact, thereby extending its service life and that of the rollers. Maintenance teams were also quick to report improvements in sealing, with no obvious signs of dust adhering to the back of the straps.
