CASE STUDY: K-Redi-Liner[®] Ceramic

Product category:	Flow & Anti Wear
Location:	Wagga Wagga, New South Wales
Conveyed material:	30mm crushed river rock
Previous wear liner:	CC 1500 Chromium Carbide
Previous wear liner life:	6 months
Kinder Aust wear liner installed:	<u>K-Redi-Liner[®] Ceramic G83A</u>
Current wear liner life:	2 ½ years
Current wear:	30%
Installation date:	January 2011
Last inspection date:	May 2013

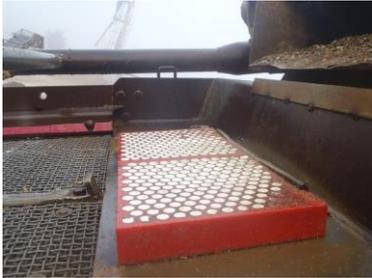
2011 photo of K-Redi-Liner[®] Ceramic in place after 6.5 years

However straightaway I was impressed by how easy they were to bolt on – much quicker and needing less manpower than the steel plate. And the individual panels are very effective because they can be placed only in areas of high-wear with no modifications required.

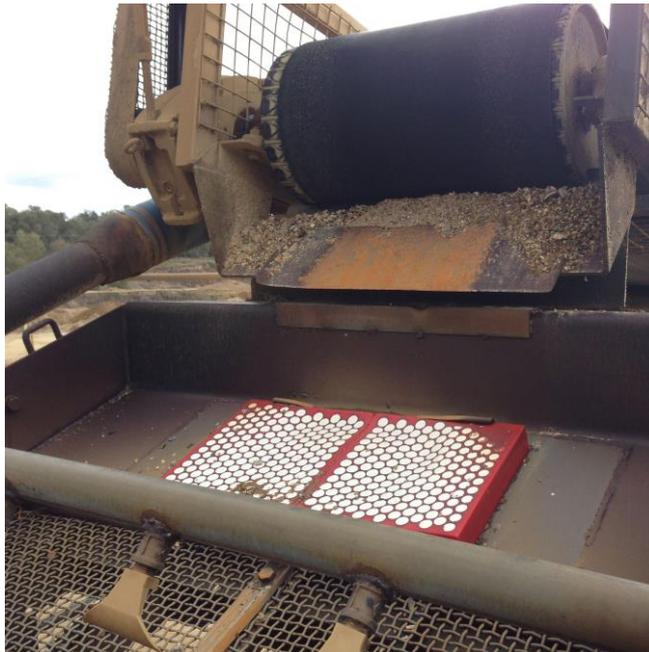
2013 photo of K-Redi-Liner[®] Ceramic Lining still in place after 2 years and 4 months constant use

It’s coming up to 2 and half years now since we first installed the K-Redi-Liner[®] and I couldn’t be more delighted in how they have performed. Less stoppages means our productivity output rates have increased so we can meet customer demand quicker.”
