## CASE STUDY: K-Rotabrush® Conveyor Belt Cleaner

<b>Kinder Australia Product:</b>	<b><u>K-Rotabrush® Conveyor Belt Cleaner</u></b>
<b>Product Category:</b>	Belt Cleaning System Products
<b>Location:</b>	Victoria
<b>Conveyed Materials:</b>	Basalt Quarry Products
<b>Production Capacity</b>	100 tonnes per hour
<b>Installation Date:</b>	August 2017

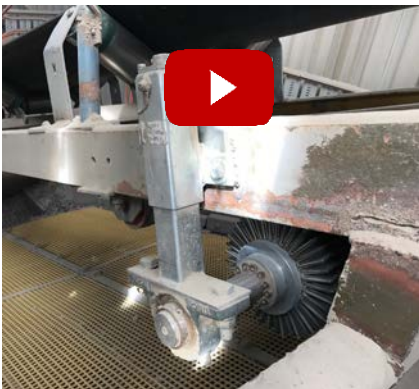
**ABOVE**  
Image K-Rotabrush® Conveyor Belt Cleaner Installation

K-Rotabrush® conveyor belt cleaners installed at the quarry, consisted of a rubber brush design and featured a high performance, uniform rotatory action successfully sweeping excessive fines off the belt. This greatly reduced the instances of carry back on the return rollers and helped to stabilise belt tracking, improved conveyor operation and plant efficiency.
