CASE STUDY: K-Sure[®] Belt Support and K-Ultra Dual[®] Seal

Kinder Australia Product:	K-Sure[®] Belt Support and K-Ultra Dual[®] Seal
Product Category:	Belt Support and Conveyor Skirting and Sealing
Location:	Asia Pacific Region
Conveyed Materials:	Lime
Conveyed Belt Width/Speed:	800mm / 1 metre per sec
Rate / tonnes per hour	100
Installation Date:	May 2017

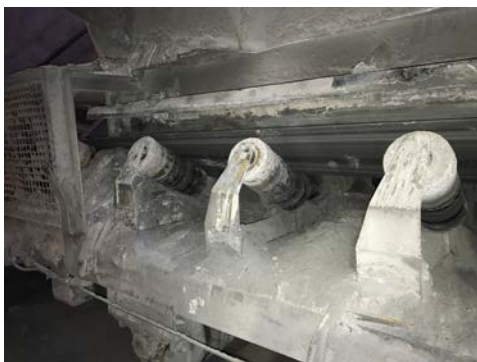
RIGHT
Image
BEFORE Installation

Site inspections at the plant exposed major inefficiencies in material flow, as well as excessive material spillage and dust emissions between existing skirting and conveyor belt, due to the distance between frames. These inefficiencies resulted in frequent shutdowns and spiralling clean-up costs necessitating recruitment of an external cleaning contractor to manage material spillage minimising environmental and potential safety hazards.

Premature belt wear and tracking issues were also identified, with material becoming trapped under the conveyor belt and accumulating on the conveyor structure.

After two previous faultless installations of **K-Sure® Belt Support System** and **K-Ultra Dual® Seal** at the site, it was agreed this combined solution be rolled out within the plant's impact zone, under the chute. Two extra **K-Sure® Belt Support** frames were introduced to reduce gap support to 300mm solely for rail support, including a lead on frame.

The existing conveyor belt was removed and frames packed carefully to ensure 100% linear surface. Prior working knowledge of the plants intricacies meant installation was conducted seamlessly & efficiently, with minimal time and labour, including drilling of extra frames.

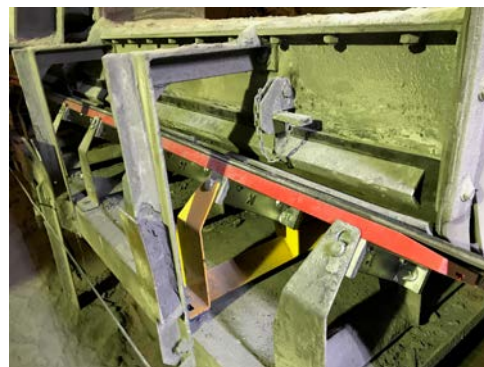
LEFT
Image
AFTER Installation

The plant can confidently confirm the recommended conveyor belt support and skirting solution has exceeded its performance expectations, with virtually no material spillage plus the facilitation of a continuous and uninterrupted flow of conveyed materials throughout the plant. Other positive outcomes include significant clean-up costs savings due to reduction in material spillage and dust containment.

K-Sure® Belt Support System supports the conveyor belt by absorbing the full impact of conveyed material at the transfer point. Delivering minimal belt damage, premature wear and importantly, a longer lasting conveyor belt. In addition, the **K-Sure® Belt Support system** simultaneously maximises the effectiveness of the **K-Ultra Dual® Seal's** intended function.
