CASE STUDY: K-Sure®, K-Shield Impact Belt Support, K-Ultra Dual®

Kinder Australia Product:	K-Sure®, K-Shield Impact Belt Support, K-Ultra Dual® and Return Vee Plough
Product Category:	Conveyor Skirting & Sealing
Location:	Victoria
Conveyed Materials:	Hornfels Hard Rock
Installation Date:	September 2016

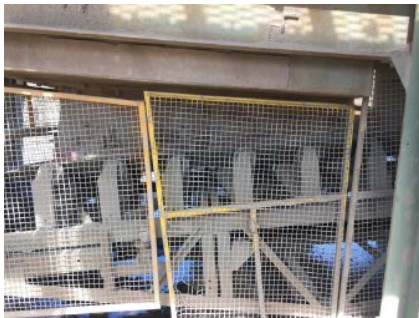
The transfer point under the tertiary crusher was a source of excessive spillage and dust emission. After many years of service and increased load due to plant productivity increases the belt was at capacity. This resulted in the area flooding and not containing the crushed material.

Material turbulence generating huge amount of dust in the tertiary crushing process, was ultimately escaping and causing constant emissions from conveyor belt skirting system. Dust had been reported to cause issues and blockages of the spray nozzles and the site had attempted wetting the product, however this led to binding the screens further along in the next process.

With the vertical impact drop height from the cone crusher being 2.5m and a lump size of minus 60mm provided evidence that the material was pooling, due to the material not moving in the direction of the conveyor belt. A combination of conveyor belt sag and inconsistent conveyor idler profile resulted in an ineffective skirting system, therefore resulting in the dust emissions and spillage.

ABOVE
Image of Transfer point **BEFORE**
Conveyor Upgrade

After an in-depth report was submitted, this Quarry elected to overhaul the conveyor by fabricating a new tail section and followed recommendations to install: a **K-Shield Impact Belt Support System**, a **K-Sure® Belt Support System**, **K-Ultra Dual® Seal Skirting System** and a Return Vee Plough.

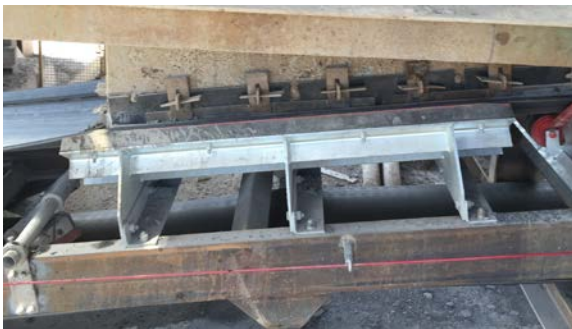
All 3 systems were installed during the week of the 19/09/2016. During the first follow-up meeting between the Kinder Australia Pty Ltd Operations Management and the Maintenance Team, on the 20/10/2016, it was recorded that the project upgrade was perceived as a very positive success, with minimal reported dust from the skirting system. The only dust reported was observed to be appearing from another source near the crusher discharge.

A second follow up meeting with the Maintenance Team, was conducted on the 06/01/2017 and it was advised that the upgrade was continuing to meet the site's expectations. Some additional positive observations, in that the site had experienced a reduction in downtime in the area, as the skirting hadn't required any adjustment since the installation, usually conducted monthly.

This was understood to be a combined result of the conveyor belt sag not allowing material to get up under the skirting, causing a pinch point and the polyurethane skirting tip, being an abrasion resistant material.

ABOVE
Image of Transfer point AFTER
Conveyor Upgrade
