CASE STUDY – K-HD Polyurethane Side Guide Roller

Kinder Australia Product:	<u>K-HD Polyurethane Side Guide Roller</u>
Product Category:	Conveyor Belt Tracking
Location:	South Australia
Conveyed Materials:	Basalt – Quarry Products
Conveyed Belt Width:	600BW
Installation Date:	December 2015

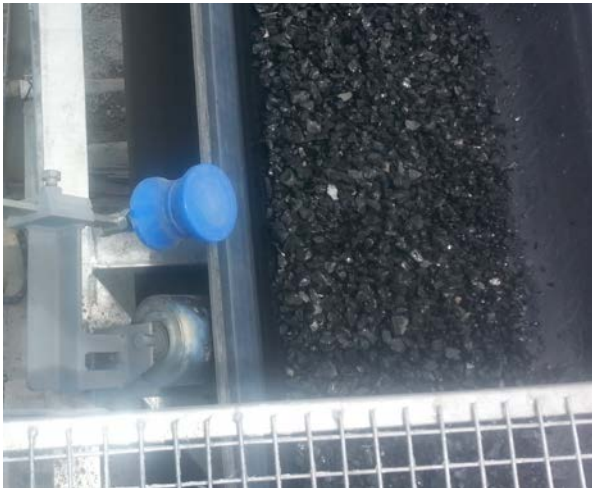
Kinder's Field Applications Team were invited by the Quarry Manager to assist with identifying and resolving a belt tracking issue on their conveyor, located at the discharge end of a horizontal screen and prior to an aggregate bin loading point. The chute whilst correctly mounted above the conveyor, together with the slow material feed was not effective in projecting the material towards the centre of the chute.

The non-centralised nature of the material loading caused the conveyor to consistently track to the left-hand side, resulting in ineffective skirting and material spillage as well the associated maintenance cleaning up issues/costs. Other observations suggested by the Quarry Manager included potential damage to the chute, belt and nearby conveyor structures.

LEFT
K-HD Polyurethane Side Guide Roller Installation

Redesigning the chute loading to the conveyor was initially suggested, but later concluded not practical or feasible for the quarry operation. Site inspections identified Kinder's **K-HD Polyurethane Side Guide Rollers** as the best option. The installation of these side guide rollers in strategic positions would act as an effective barrier to prevent further belt mistracking and successfully hold the belt in a central position.

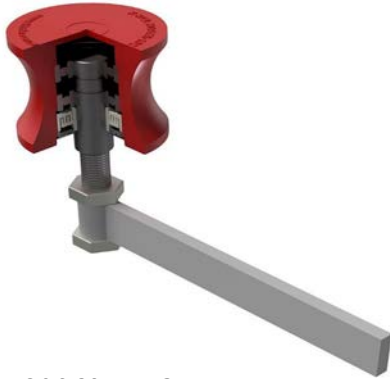
K-HD Polyurethane Side Guide Roller

K-HD Polyurethane Side Guide Rollers are specifically designed to control and/or correct any belt tracking misalignments. The action delivered from these side guide rollers stops the conveyor belt from tracking any further than the installed roller.

K-HD Polyurethane Side Guide Rollers feature highly durable, longer lasting polyurethane. Its concave design is far superior compared to flat steel guide rollers and helps force the belt back down onto the idler rollers, eliminating potential belt mistracking issues.
