Case Study – The Essential SNAP Seal - Dust Containment Combination

Kinder Australia Product:	<u>K-Sure® Belt Support, K-Containment® Seal, K-Snap-Loc® Dust Seal</u>	 
Product Category:	Conveyor Skirting & Transfer	
Location:	South Australia	
Conveyed Materials:	Iron Ore	
Conveyor Belt Width:	1200mm wide	
Production Capacity:	90m/min, 400 – 600 tonnes per hour	
Installation Date:	Feb 2022

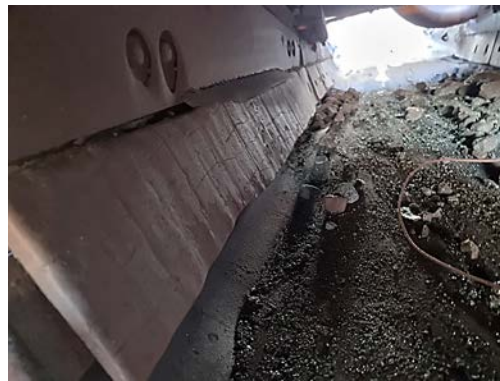
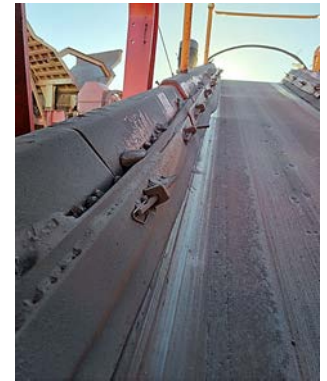
BEFORE PHOTOS: Duo plate hard/rubber skirting prior to Kinder's dust solution installation.

During the initial discussions, the Maintenance Supervisor expressed major concerns for one key transfer point presenting with excessive dust emissions and spillage which in turn dampened safety, efficiency, and productivity. For many years the operator relied on duo plate hard skirt and rubber skirt to combat dust and spillage within this targeted transfer point.

The conveyor belt had the tendency to dip between trough idlers giving rocks the opportunity to get trapped between the hard skirt and the standard black skirting rubber. Conveyed rocks would also damage the belt when coming up against the next idler. Of significant concern was the high level of dust and spillage from the sagging belt between the idlers. Product loss from recurrent material spillage was costly, spillage needed to be cleaned out daily by maintenance teams diverted from other parts of the plant to minimise potential OHS hazards, further negating operational costs.

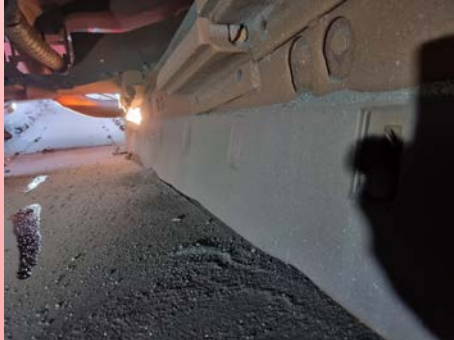
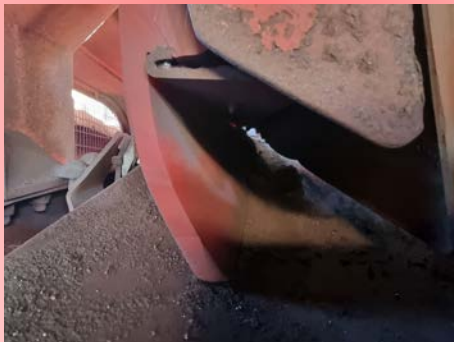
AFTER PHOTOS:
Kinder The Essential SNAP Seal - Dust Containment after installation.

The operator turned to Kinder for our expertise in transfer point optimisation and in particular dust/spillage suppression. **The Essential SNAP Seal – Dust Containment Combination** was recommended and installed to address the belt sag, dust emission and material spillage issues.

K-Sure® Belt Support System, low friction design was very successful in resolving the belt sag problems experienced where there were few idlers installed at the impact load point. K-Sure® provided solid, stable and consistent support within the targeted transfer point. The added advantage of no moving parts translated to less repair and no ongoing maintenance costs.

Effective suppression of dust and material spillage can be attributed to the installation of **K-Containment® Seal**, providing first line defence and further enhancing the effectiveness of the **K-Snap-Loc® Dust Seal** (outer seal). Made of engineered high-performance polyurethane, K-Snap-Loc® is ideally suited to this high abrasive environment.

Prior to the Kinder installation, removal of old steel and the fitting of **The Essential SNAP Seal – Dust Containment Combination** was completed by a boilermaker and fitter during a 24-hour production shut down. The belt was later removed and changed to aid seamless fitting.

K-Sure® Belt Support System has made a huge difference in keeping the belt flat and allowing the skirt to perform properly and keep in the dust. Material spillage under this belt has been greatly reduced (weekly clean) saving the crews daily cleaning in a tight and confined space and reducing their exposure to injury by not having to shovel out fine dust.

The **K-Containment® Seal** is wearing well and is easy to lower when required. Very pleased with the overall Kinder dust containment solution, the operator is now considering fitting this same system on another transfer point loading area of the plant.
