Editorial – Minimising Skirt Grooves in Conveyor Belt

Minimising Skirt Grooves in Conveyor Belt – The Billion-dollar problem no one has solved.

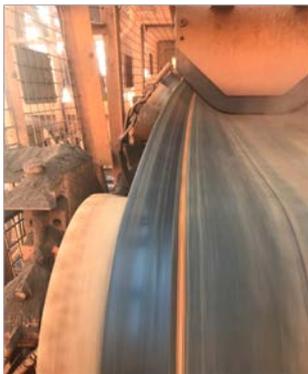
Photo: Typical groove caused by product build-up in skirted section.

When fines leak under the hard skirts, they enter the cavity, bulge the soft skirts creating sticky abrasive clumps that remain static and rub against the top cover of the conveyor belt. The belt is then continually subjected to this abrasive build up, which subsequently creates the unwanted grooves. As the grooves become deeper, the issue compounds as more material is allowed to escape under the hard skirts.

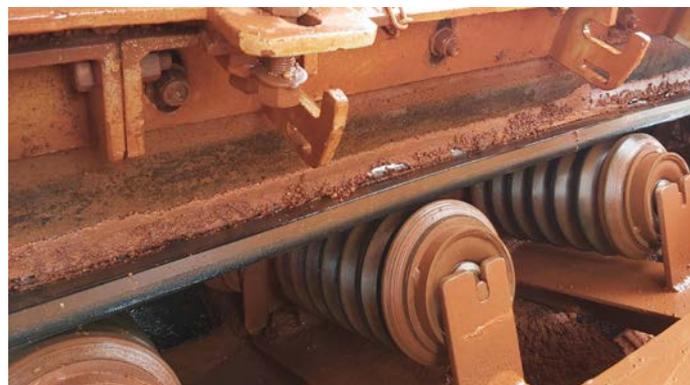
Photo: Typical product build up behind hardskirt.

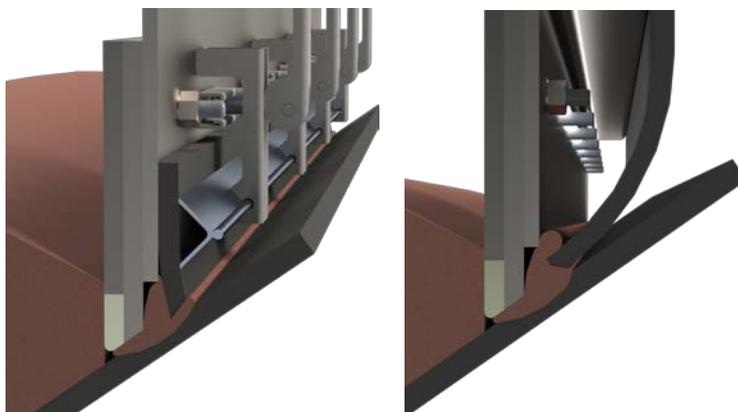
Left & Right: Product jammed and wearing the belt, both common setups shown.

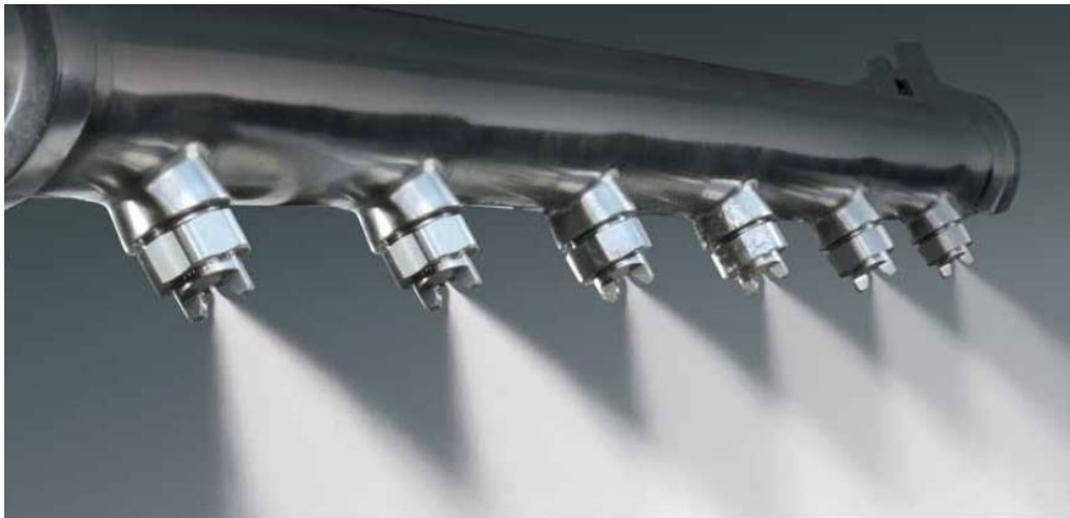
Above: Stainless-Steel High-Pressure Water Spray Manifold

However, the combination of a high-pressure water spray combined with the low friction, engineered self-adjusting polyurethane soft skirting, allows for programmed automated cleaning which cleans away the sticky abrasive clumps previously causing the conveyor belt top cover damage.

The flow rate and timing of added water jets are programmed by the sites' PLC (programmable logic control systems). This will allow for the correct amount of water to be used and keeping moisture levels within specification.

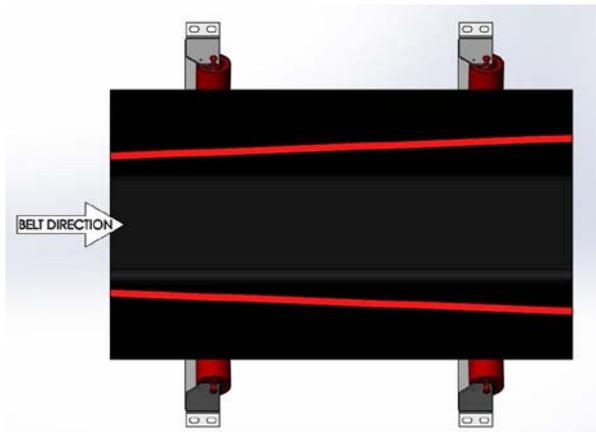
Left:
Birds eye view showing this exaggerated orientation skirt versus belt.

To reduce the concentrated grooving caused by turbulent material and or dust sandwiched between the skirting material and your conveyor belt, the orientation of chute and skirting parts should ideally NOT be parallel to the conveyor belts running direction.

This offset or bias orientation will help significantly to aid material flow when exiting the chute, and importantly spread the unwanted damage to your conveyor belt over a larger cross-sectional area, thus extending the life of your belt.

The time it takes for the grooves to appear in your conveyor belt is exponentially proportionate to the offset bias in your chute or skirting alignment.

For example, if your skirting material is 12mm thick, and the offset distance is just 6mm from the beginning and end of the skirted section, you will find that any groove damage should decrease by more than just 50%.

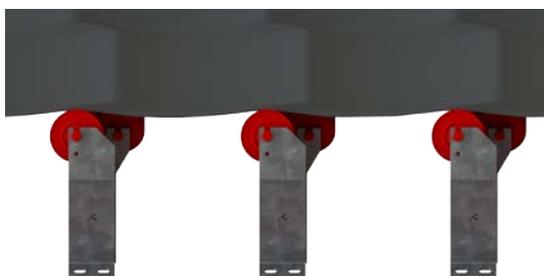
Above Left: Belt Sag Between Idlers

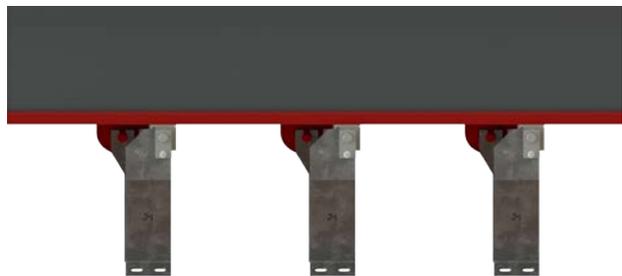
Above Right: Belt Support replacing rollers

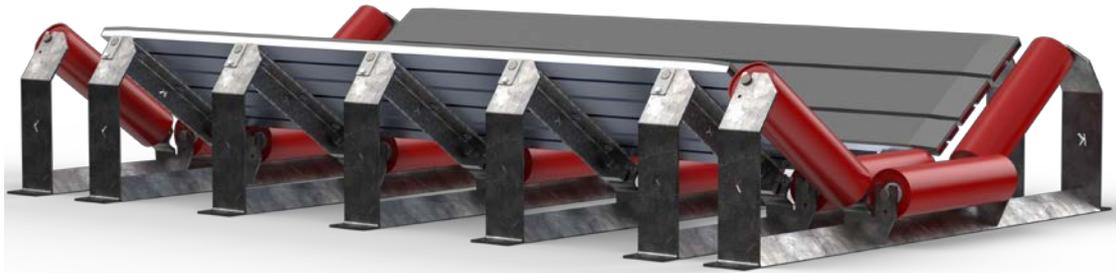
Above: Typical Example of Belt Support Assembly

Providing an even or flat surface for the conveyor belt to be supported in the loading or transfer point, is paramount in reducing the amount of fugitive material escaping under the hard and soft skirts.

Historically the belt support and impact beds of yesteryear had their limits of belt speed and pressure, which ultimately lead to premature wear if installed in the wrong locations, however there are now transfer point support materials available that can withstand higher temps and pressures for these high capacity transfer points.
