## Case Study – K-Cleanguard Belt Pre-Cleaner

<b>Kinder Australia Product:</b>	<b>K-Cleanguard Belt Pre-Cleaner</b>
<b>Product Category:</b>	Conveyor Belt Cleaning
<b>Location:</b>	Antofagasta, Chile
<b>Conveyed Materials:</b>	Leached copper ore
<b>Conveyor Belt Width:</b>	1829mm
<b>Production Capacity:</b>	6.2 m/s, 9.000 tonnes per hour

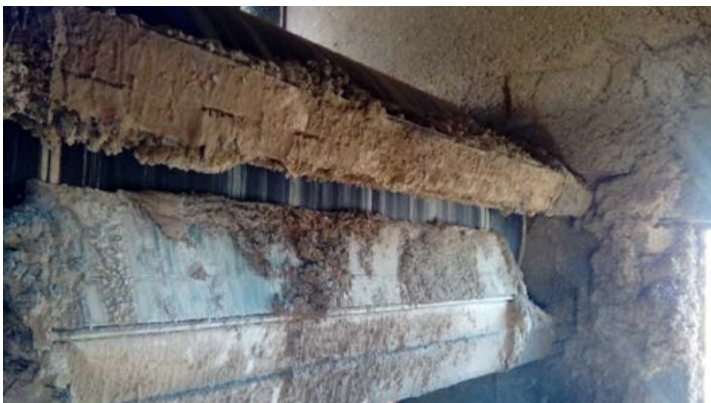
Antofagasta Minerals Antucoya operation had been experiencing low wear life of their primary belt cleaner blades installed within their reclaiming conveyor system, which has a throughput of 9.000 tph, mostly using conveyors with 1829mm wide belts at 6.2 m/s.

The accelerated wear of these blades was a consequence of the main ore flow hitting the blade, instead of flying it off at the discharge pulley. This unexpected condition was a consequence of high moisture content in the ore, which turned it into a highly cohesive slurry that stuck firmly to the belt.

This condition was so demanding on the primary belt cleaner that the blades were completely worn in one day, and resulted in major carryback issues, having to force downtimes only for cleaning carryback spillage in critical locations.

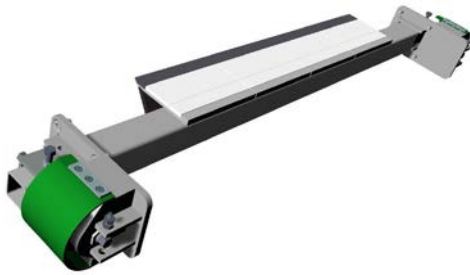
#### K-Cleanguard Belt Pre-Cleaner

We recommended installing **K-Cleanguard Belt Pre-Cleaners** at the discharge of every conveyor, focused on separating the main ore flow of the conveyor belt and extending the wear life of the primary belt cleaner's blade. A special pre-cleaner wear plate had to be designed for Antucoya's operation, since their condition was even more severe than others experienced before, using the most resilient materials available.

After installing the **K-Cleanguard Belt Pre-Cleaners** the client was able to extend the wear life of the primary cleaner's blade by a factor of 14. This allowed for two weeks between blade replacements (improving over a job that was done on a daily basis), drastically reducing man-hours and worn blades, and furthermore allowing replacements to take place during normal scheduled maintenance downtimes.

The **K-Cleanguard Belt Pre-Cleaner's** specially designed wear plates also showed an exceptional wear life of 45 days in these conditions, where regular pre-cleaner wear plates would barely have lasted a week.

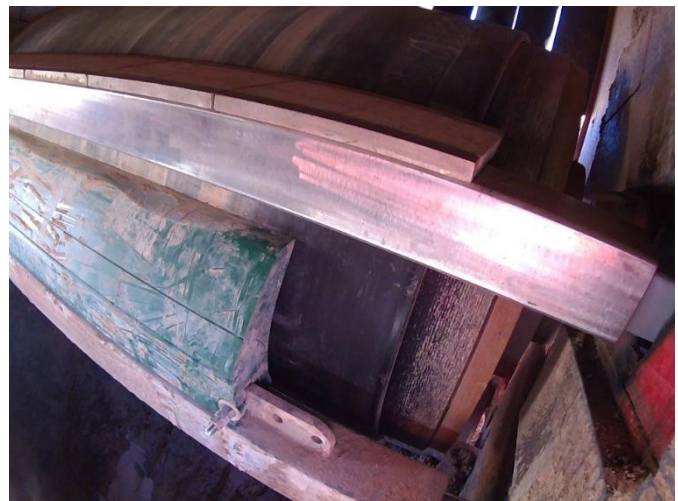
**The belt cleaning arrangement shows better performance and is now much more consistent and predictable, which also reduced the cleaning downtimes.**

Although the customer had to go through the extra expense of buying specialty pre-cleaner wear plates, the total cost in cleaner blades was reduced due to the decrease in primary cleaner blade demand, which had an overcompensating effect. Additionally, the plant's availability went up significantly as did the mean throughput of the area, demonstrating the importance of working with a top-tier custom built belt cleaner arrangement.
