Case Study – K-Deblinding Rods

Kinder Australia Product:	<u>K-Deblinding Rods</u>
Product Category:	Screening Products
Location:	Victoria
Conveyed Materials:	Non-Descript Crushed Rock (NDCR)
Production Capacity:	400 – 500 tonnes per hour
Installation Date:	Dec 2022

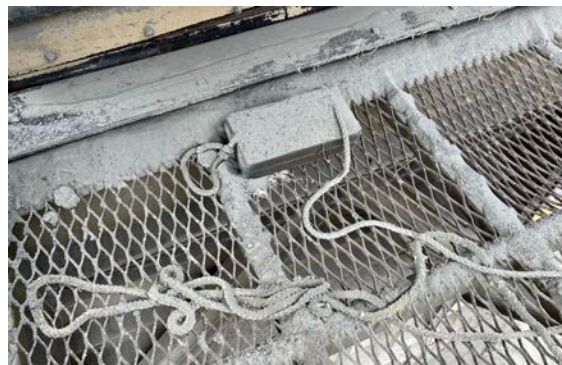
BEFORE PHOTOS: Rubber block attached to rope.

Due to the high moisture content and fine particles in the material being screened, blinding/clogging issues was observed within its multi-storey screening facility. Screening machines are designed to separate and sort the various types of conveyed rock material. Feed material that didn't flow and filter through easily would start to accumulate layer by layer and overflow onto the sides of the screens. The clogging issue was further dampened during wet and humid weather.

The blinding of the screens resulted in reduced screening efficiency, increased downtime, and increased maintenance costs. To date, the Quarry Manager used a rubber block attached to rope, daily manual adjustment and intensive block shaking was required to unclog feed material. Tired of this time consuming and labour-intensive process, the Quarry Manager sought the expertise of Kinder Field Applications Specialist to recommend a cost-effective solution to effectively eliminate blinding, improve screening efficiency, and stem further product loss.

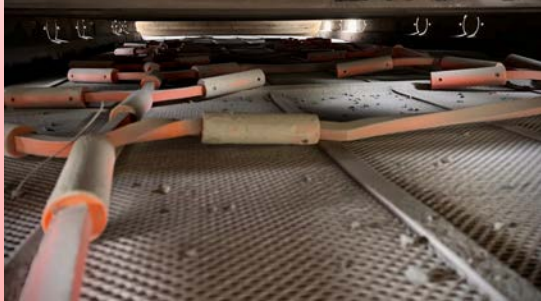
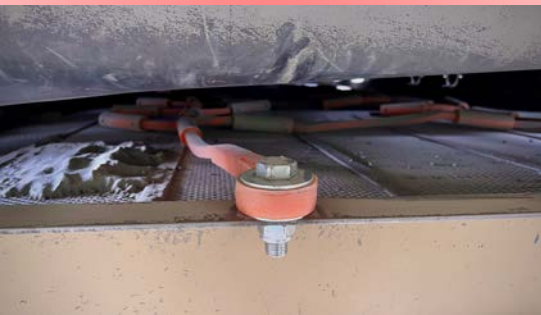
SOLUTION: K-Deblinding Rods

AFTER PHOTOS:
K-Deblinding Rods & anchor points successfully installed above the screens to resolve the blinding issues.

The K-Deblinding Rod solution is designed to eliminate blinding in screening applications. The rods are made of high-quality polyurethane and are placed on the screening surface, where they vibrate at a high frequency to prevent material from sticking to the surface.

Only two of anchor points were drilled to the attached application assembly, taking no more than 30 minutes all up. The team installed the rods on the screening machines and provided training to the company's personnel on the proper use and maintenance of the equipment.
