Case Study – The Essential SNAP Seal, K-Commander® Conical Tracker & K-AllShelter® Covers

Kinder Australia Product:	The Essential SNAP Seal, K-Commander® Conical Tracker & K-AllShelter® Covers
Product Category:	Conveyor Skirting & Transfer Conveyor Belt Tracking Covers & Enclosures
Location:	New Zealand
Conveyed Materials:	Gypsum Rock
Belt Width Prod. Capacity:	1200mm / 750mm / 650mm Varies 1000 / 300 / 100 / 10
Installation Date:	Feb - October 2022

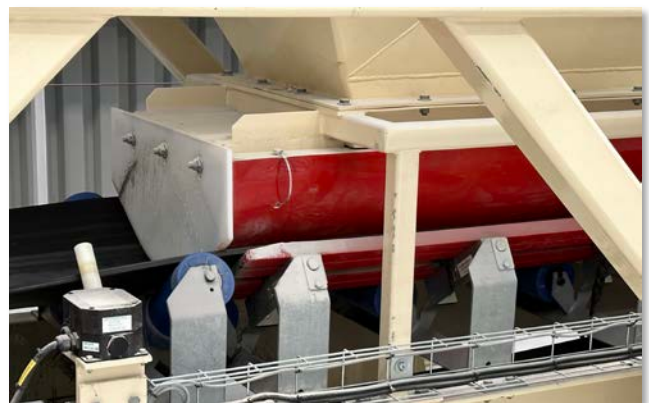
As part of the targeted dust / spillage solution, the design included Kinder's the [Essential SNAP Seal](#), belt support and skirting solution, seven in total within the conveyor system's seven primary load zone areas. Installing [K-Shield Impact Belt Support System](#) onto the biggest conveyor made sense as it was the taking the largest throughput and fullest impact.

For the lower throughput conveyors, the operator opted for the installation of Kinder's side skirting / belt support solution, [K-Containment® Seal](#), [K-Snap-Loc® Dust Seal](#) and [K-Sure® Belt Support System](#) with a rolling element.

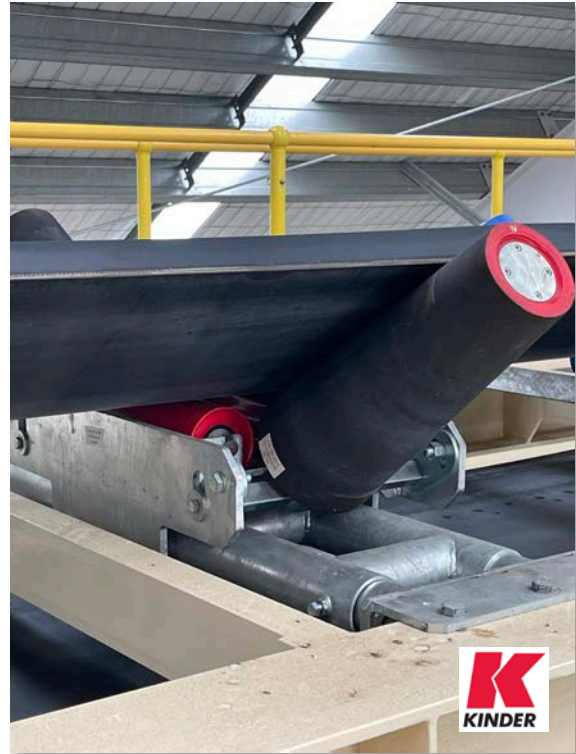
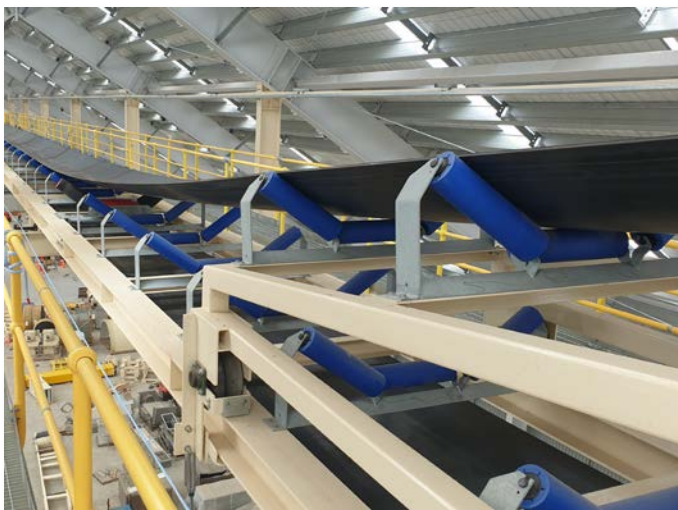
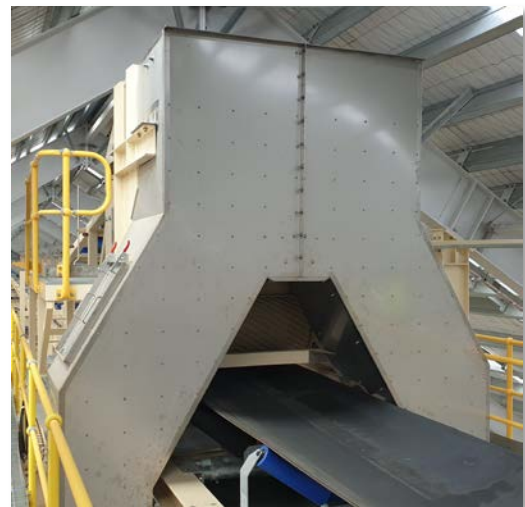
To elaborate, the intake conveyor is 260m long, including a 100m incline section. The last 100m uses a tripper car to discharge the gypsum into the storage hall via a dual chute, which requires lifting the belt anywhere along this length.

There was not a lot of room between the chutes as space was at a premium. Traditional trough trackers with side rollers would not allow the belt to lift as required, and many other conical style trackers have outer supports that are too wide to fit inside the tripper frame and chute.

Our NZ Distributor's Engineering Partner didn't want to risk leaving the belt untracked over this length, particularly as it is picked up and put back down by the tripper at a variable location. In this instance, K-Commander® Conical Trackers were the perfect fit, six K-Commander® Conical Trackers were easily bolted into place and fitted nicely between the chutes.

Keeping the belt correctly tracked along the tripper path will elevate the overall reliability of the conveying process. Thanks to the K-Commander® Conical Tracker, proprietary designed and engineered by Kinder, conveyor reliability is assured.

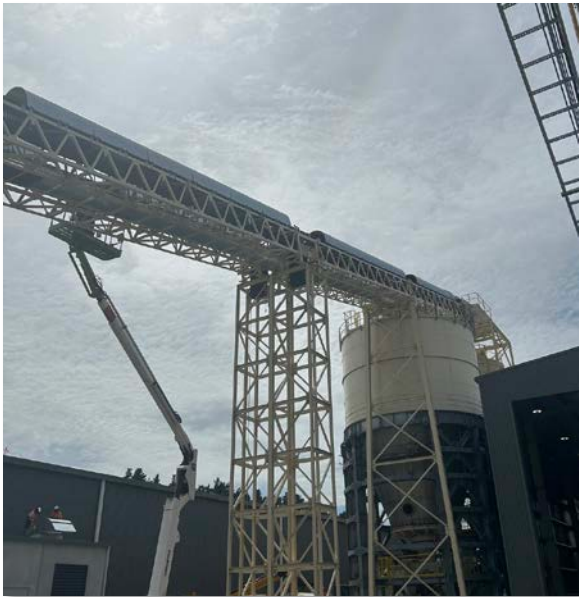
SOLUTION: Conveyor Covers

With conveyor safety also at the core a total of 575 metres of K-AllShelter® Capotex Conveyor Covers was installed as an effective way of reducing dust emissions from the conveyor system.

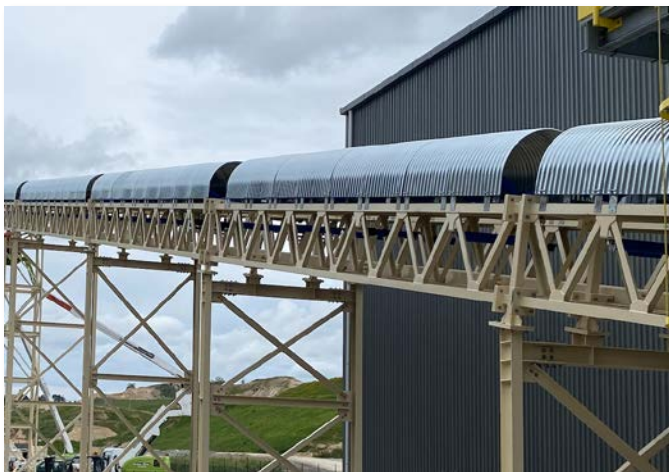
The conveyor covers also are highly effective in providing a physical barrier and protecting maintenance staff from the health risks of uncontained dust, reducing the environmental impact of dust emissions, as well as keeping conveyed product dry from rain.

535 metres of Capotray was also installed in conveyor areas over a certain height, where falling debris can lead to serious worker injuries if not contained.
