Case Study – K-Floshield® Polished High Chrome Liner

K-Floshield® Polished High Chrome Liner

Materials Flow Solutions

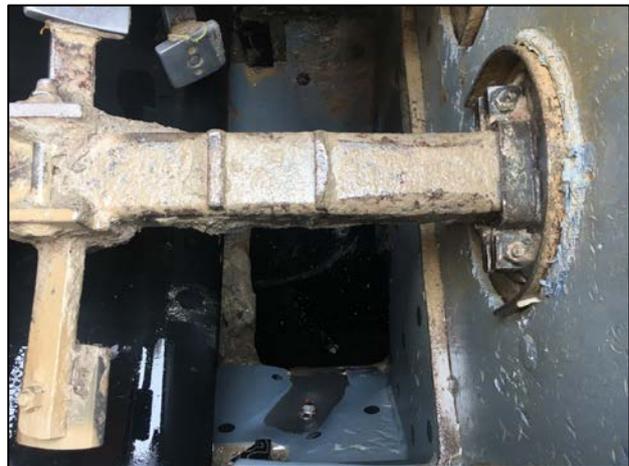
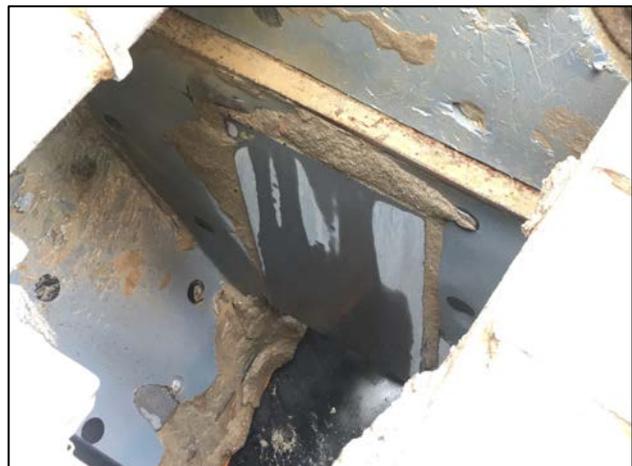
One of the final processes, the aggregate is combined and blended within the plant using a pugmill to produce its quality sellable products. This process mostly involves the additive of water amongst others to an already abrasive bulk material mix, resulting in a sticky solution which the site was observing in the form of hang up on the pugmill walls, floor and other surrounding chutes. Our customer reported that, due to some blockages, operators would be hosing out the pugmill multiple times a shift and in some instances, would have to isolate the plant and manually remove the hardened material.

Previous Wear Liner Install (after 3 months service)

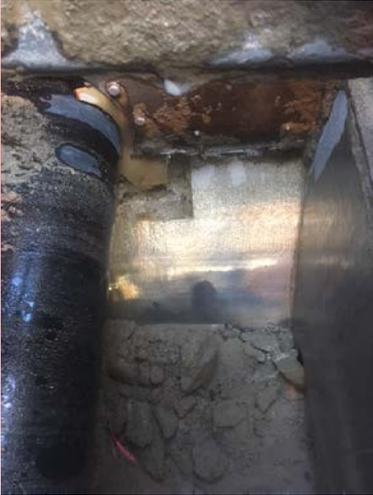
K-Floshield® Polished High Chrome Liner

The K-Floshield® Polished High Chrome Liner's purpose is to combat both extreme abrasion and hang-up via its integration of a pre-polished chromium carbide overlay on a mild steel backing. By polishing the K-Floshield® Polished High Chrome Liner, a reduction in friction coefficient is achieved, aiding to the slipperiness of the wear liner.

After speaking with Kinder Australia about the issue, it was recommended they proceed with an installation of Pugmill Liners such as K-Floshield® Polished High Chrome Liner, highly effective when utilised in heavy duty applications.

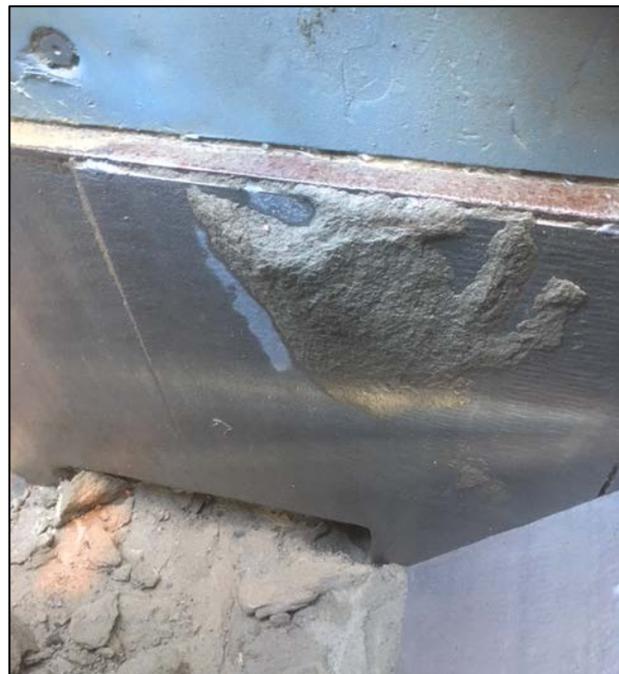
K-Floshield® Polished High Chrome Liner

After 3 months and 123,609 tonnes of 20mm minus crushed concrete, brick and cement treated concrete later, the Pugmill Liners performance was checked again to see how the material was wearing and the customer happily reported that the 'any wear was almost negligible' and the 'initial weld line was still present in the wear liner'.

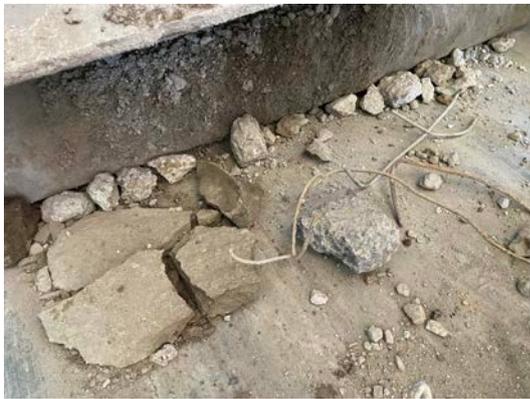
With the ongoing success of K-Floshield® in the plant's pugmill, the operator trialled Kinder's innovative K-Floshield® Liner at plant's pan feeder location. The pan feeder collects and doses varying size/types of sand, mud, clay, bricks, rocks etc and is notorious for frequent hang ups and production shutdowns. A low-grade liner material was previously used, this did not resolve the hang up issues and the abrasive/sticky nature of materials collected in the pan feeder.

Photo Left: Pan Feeder collects & doses sand, mud, clay, bricks, rocks and experiences frequent hang ups.

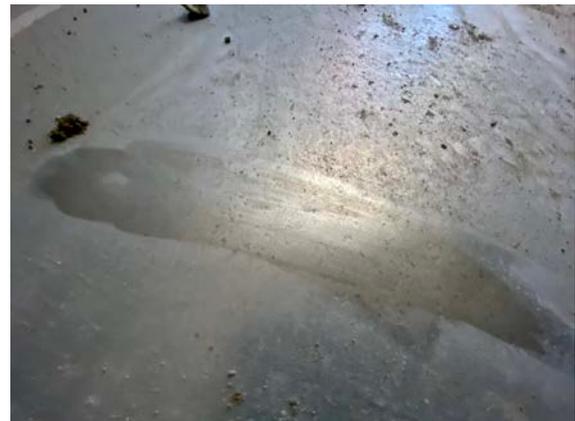
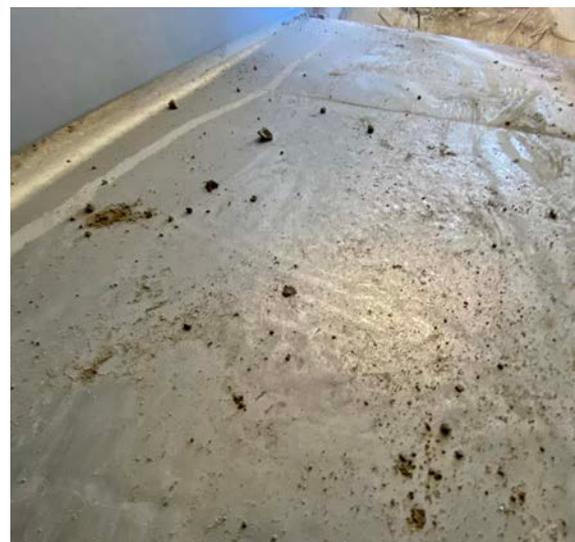
K-Floshield®'s has withstood 350,000+ tonnes of recycled material thus far, and with the liner surface still intact and showing virtually no sign of wear and tear the client expects many seasons ahead before replacement. This is worthy of mention and applaud!

Photos Above: K-Floshield® after install shows no signs of wear and maintains original shine and slipperiness. Hang up issues resolved.
