Case Study – AirScape®, TailScape & K-Containment® Seal

Kinder Australia Product:	<u>AirScape®, TailScape & K-Containment® Seal</u>
Product Category:	Conveyor Skirting & Transfer
Location:	Brisbane, QLD
Conveyed Materials:	Clay, raw material for brick manufacturing
Conveyor Belt Width / Speed:	750mm Belt Width / 1 m/sec
Installation Date:	January 2025

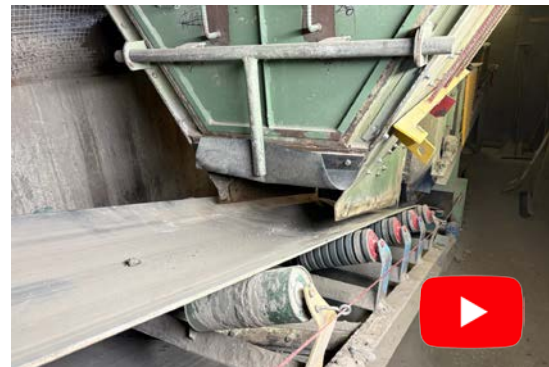
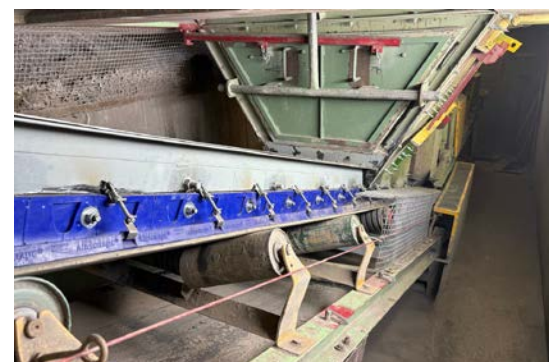
The brick manufacturer faced significant challenges with dust and spillage at the tail end of an incline conveyor used for transporting clay to a crusher. The basement location of this conveyor provided limited access for cleaning, making routine maintenance difficult and time-consuming.

High dust volumes also posed operational and environmental concerns, while excessive spillage increased clean-up efforts and reduced overall efficiency. The previous use of skirting rubber proved ineffective in containing material and controlling dust.

Before & After Photos: Dust and spillage reduced by 95% + after installing AirScape®, TailScape & K-Containment® Seal.

Following demonstrations of the AirScape® solution through our QLD Distributor, **ConBulkS**, the brick manufacturer proceeded to install a combination of Kinder's AirScape®, TailScape, and K-Containment® Seal solutions to address the dust and spillage challenges. The installation process, completed over two days, involved rebuilding and extending the chute to accommodate the AirScape® system.

- **AirScape®:** A 4-metre-long, non-contact side sealing system designed to prevent spillage and reduce dust at the conveyor transfer points. By utilising a unique air flow design, AirScape® creates an inward suction effect that contains fine dust particles while allowing bulk material to flow efficiently.

- **TailScape:** Installed at the tail end of the conveyor, TailScape enhances dust suppression and spillage control by effectively sealing the conveyor belt's return side. Its specialised design ensures minimal material loss while reducing the need for frequent maintenance and clean-up.

- **K-Containment® Seal:** A 4-metre sealing system placed inside the chute to contain material drop and flow. This seal ensures that material remains within the transfer point, reducing spillage and maintaining the efficiency of material movement through the conveyor system.

- **Additional Modifications:** Extended the rear of the chute and built a 2-metre front extension tunnel to improve material handling efficiency.

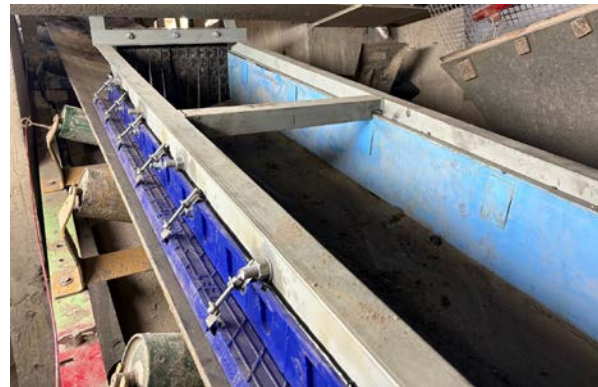
Photos: After Installation of AirScape® and K-Containment® Seal

The newly installed system significantly improved material containment and dust control. The maintenance supervisor reported a **95%+ reduction in dust and elimination of spillage**, allowing the team to focus on more critical maintenance tasks.
