## CASE STUDY: Eraser™ - Primary Belt Cleaning System

Kinder Australia product:	<b><u>Eraser™ Primary Belt Cleaning System</u></b>
Product category:	Belt Cleaning System Products
Location:	Golden Grove, South Australia
Conveyed materials:	Clay Brick
Installation date:	June 2013

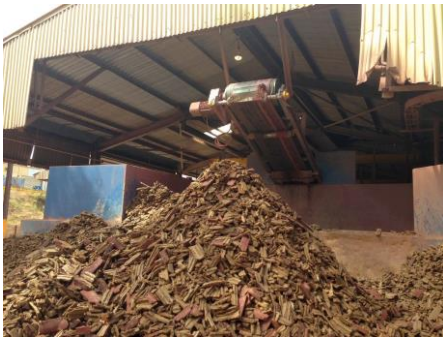
*Photo of the Eraser™ Primary Belt Cleaning System, installed at the customer brick works premises in Golden Grove, South Australia.*

After consultation with one of our sales engineers to better understand the site and conveyor structure, it was agreed that the best option was to install Kinder Australia's Eraser™ Primary Belt Cleaning System at the run-off end of the conveyor. Given the height and restricted access at the run off-point, the Eraser's unique polyurethane self-tensioning Perma-Torque™ ratchet would mean it would require minimal ongoing adjustment. As soon as the conveying of product commenced, our customer's problem was resolved in the following ways:

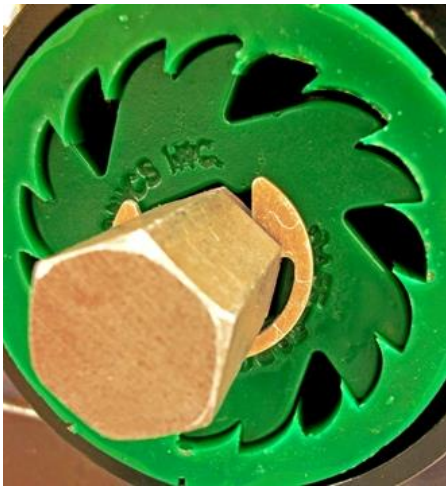
Close-up photo of the Eraser™ Primary Belt Cleaning System's self-tensioning Perma-Torque™ polyurethane ratchet.

- Proven effective cleaning performance
- Rugged mainframe and blade
- Compact mounting footprint
- No rusted springs, hoses, cables, shocks or mudpacked components to deal with
- Uniform tensioning cleaning pressure
- Brightly coloured safety yellow end caps protect from dust and water contamination
- Single pin blade attachment means quick and simple blade change out with less downtime
