CASE STUDY: K-Superline®

Kinder Australia product:	K-Superline [®] Polyurethane Lining Sheet
Product category:	Flow & Anti Wear
Location:	Dandenong, Victoria
Product description:	K- Superline [®] solid polyurethane sheet, G83 Durometer
Conveyed materials:	20mm, 17mm and 14mm aggregate and manufactured sand
Conveyed belt speed:	Vertical drop of 500mm
Installation date:	September 2014

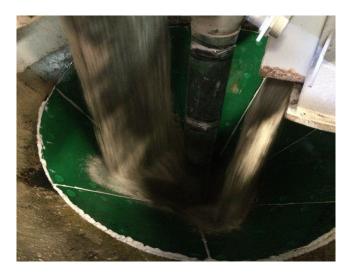
K-Superline® after installation at Dandenong, Sept 2014

Given the curved nature of the wok, 8 panels of K- Superline[®] were **water-cut to precise measurements** with a pattern of bolts replicated on each sheet.

The **bolt-on design** of K-Superline[®] has the potential of allowing worn areas to be swapped and manoeuvred with other less worn sheets. In a confined space, this can be done quickly and **without the need for welding equipment**.

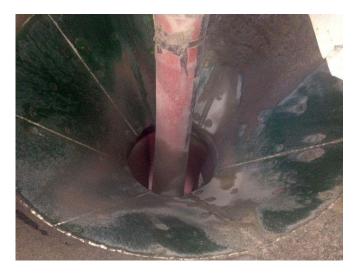
K-Superline[®] has now been installed at the Dandenong site for 5 months and is showing no signs of wear. **K-Superline[®] has exceeded our customer's expectations of its durability potential**.

Same K-Superline[®] in Feb 2015, showing no signs of wear.
