## CASE STUDY: K-Sure® Belt Support System

Kinder Australia product:	<b><u>K-Sure® Belt Support System</u></b>
Kinder Australia product category:	Conveyor Belt Support
Location:	Ormeau, Queensland
Conveyed materials:	Crushed Greywacke
Conveyor belt width:	750mm
Installation date:	October 2015

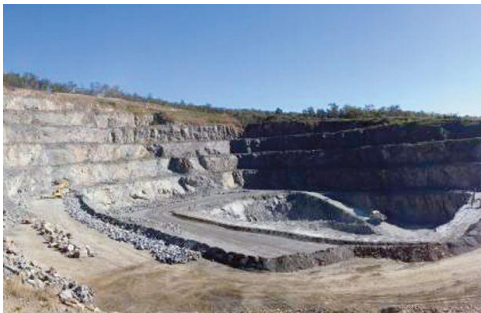
Above: customer site  
Below: 3D drawing of K-Sure® Belt Support

Our customer's site has a production capacity of approximately 400,000 tonnes per annum. Its location in the Gold Coast is situated in a large zone of meta-greywacke, handling an application with gritty characteristics. The quarry manager had identified 2 key problems:

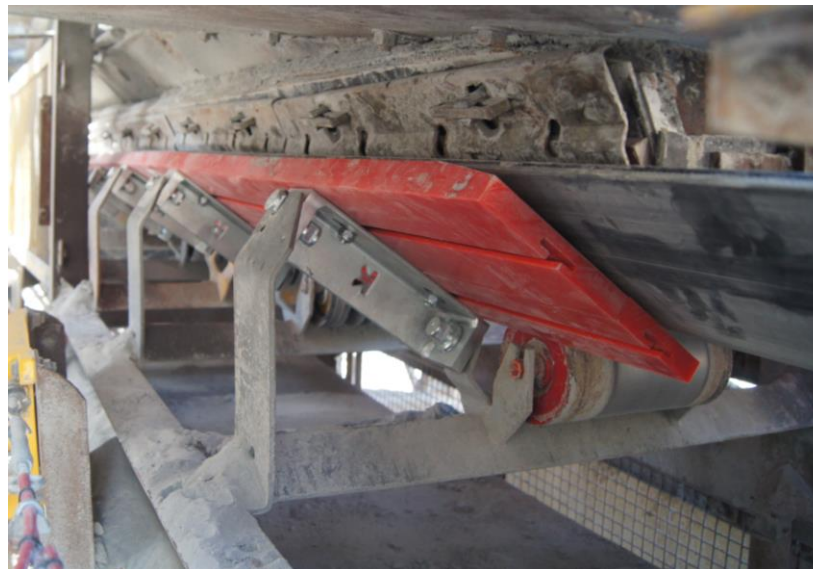
*Right: Images taken of K-Sure<sup>®</sup> Belt Support after installation*

Kinder Australia recommended the installation of the **K-Sure<sup>®</sup> Belt Support** to fix the problem of belt sag. This belt support system is designed to provide even and consistent support under the belt, utilising low friction UHMWPE sliding surface bars instead of rollers. Also, with **no moving parts that would wear in the future**, this solution will remove the need to change rollers in the awkward space.
